SERVICE BULLETIN No. 300-1-91

Subject: Main undercarriage U-spring
mounting clamps.
Inspection and/or replacement.

Models affected: EA-300

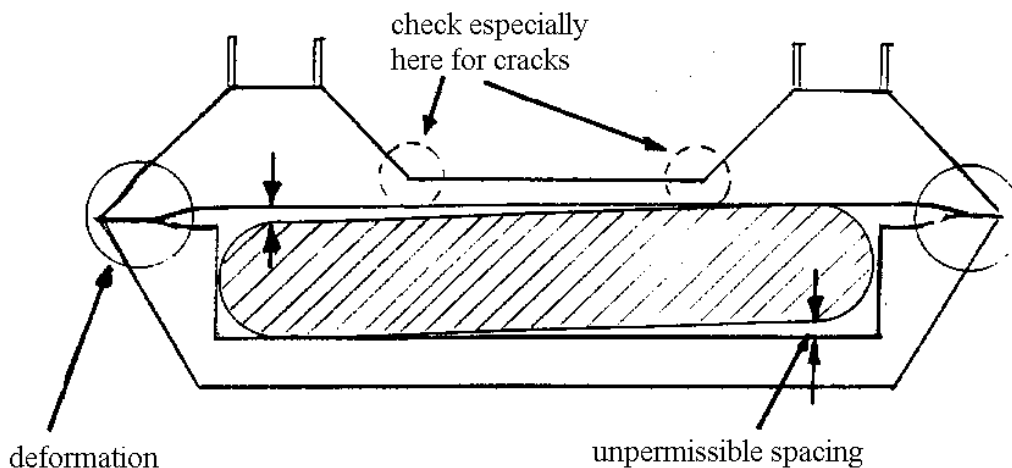
Purpose: Under certain conditions, deformations and cracks have developed in the main undercarriage U-spring mounting clamps on both sides. If cracks exist and are not corrected, the strength of the main landing gear attachment could be reduced. If deformations exist, the abrasion strips could be displaced and subsequently the glass fibre spring could be abraded. This Service Bulletin requires a repetitive inspection of the undercarriage U-spring mounting clamps to determine if cracks or deformations exist, and replacement of the main undercarriage mounting clamps with reinforced parts to eliminate the condition.

1. Remove main landing gear cuffs on both sides.
2. Inspect undercarriage U-spring mounting clamps for hairline cracks and permanently deformed areas around mounting bolts as shown on sketch "A".
3. If hairline cracks or not permissible permanently deformations are found, comply with PART II of this Service Bulletin.
4. If no hairline cracks or not permissible permanently deformations are found, replace main landing gear cuffs on both sides. Make sure of proper attachment.
5. Make appropriate logbook entry of compliance with PART I of this Service Bulletin.

Sketch "A": Possible damage of the U-spring mounting clamp

3. Remove main undercarriage cuff.
4. Remove U-spring mounting clamp, including abraision strips
5. Glue new abrasion strips to new mounting clamp (top & bottom half).
6. Install new mounting clamp. Make sure to use only new self locking nuts (as provided in replacement kit) and tighten properly.
7. Reinstall cuffs.
8. Make appropriate logbook entry of compliance with PART II of this Service Bulletin.
