SERVICE BULLETIN No. 300-3-95

Subject: Rudder Pedal Safety Control Stop

Models and Serial N° affected¹: EA-300: if factory equipped or retrofitted with the electric actuated rudder pedal adjustment produced up to 11/1995
EA-300/S: SN 001-028
EA-300/L: SN 001-015

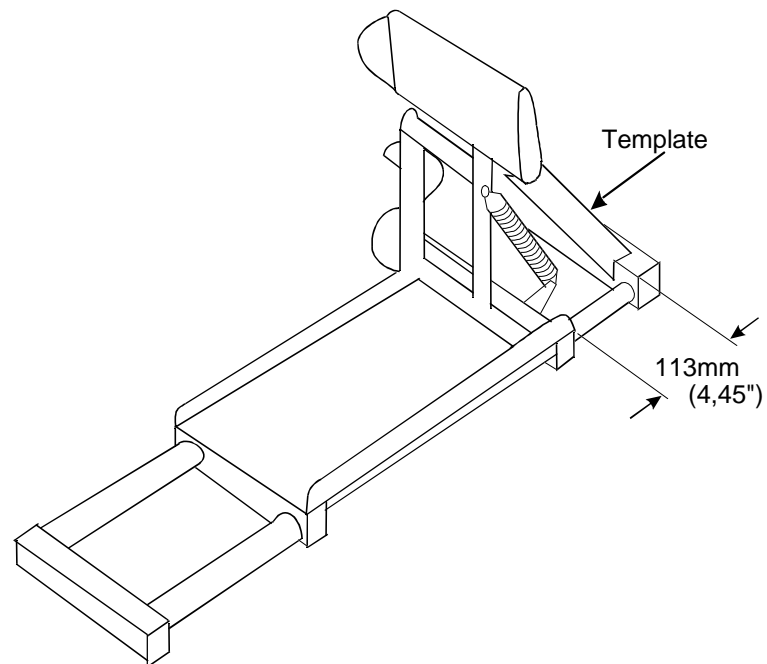
Fig. 1 Pedal center position alignment

- I.1 Check correct rudder pedal centering alignment using the procedure and template as shown in figures 1&2.

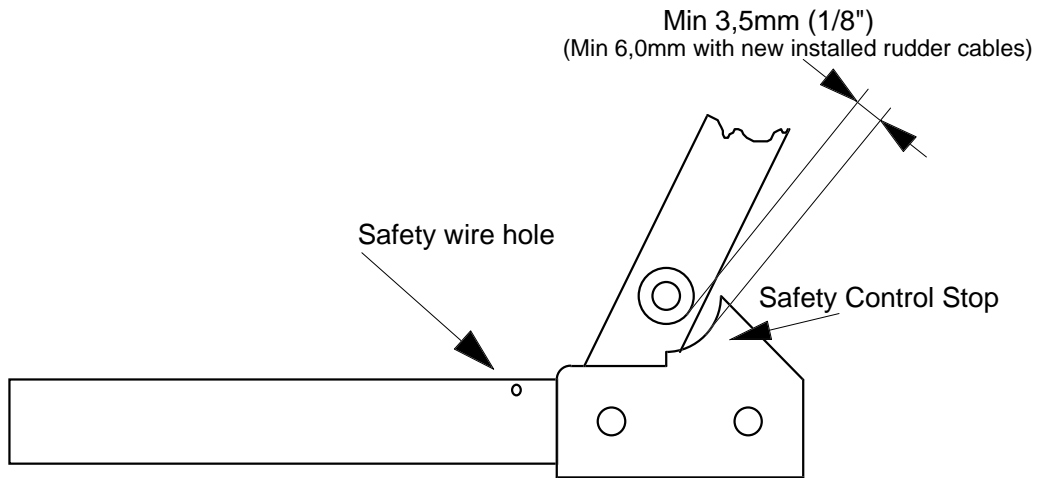
Fig. 3 Safety stop minimum clearance

- II.2 Check for minimum 3.5 mm (1/8") clearance (rudder cables having 50h flight time minimum) of the safety stop versus the rudder pedal when fully deflected, refer to figure 3; On newly installed rudder cables the minimum spacing is 6mm. This check to be performed with zero loading on the rudder pedals.

- II.3 In case the minimum clearance is not given the safety stop in most cases can be reworked. Make sure that the rework does not sacrifice the intended function of the safety stop. The rework therefore has to be checked with the rudder cables disconnected and the rudder pedals in the most forward position. In this case, simulating a broken rudder cable, the lower brake fitting shall not contact the pedal traverse base. If the safety stop can't be reworked order a new one (PN PC-44302.202-F)
