SERVICE BULLETIN

No. 300-4-04

Subject: Bottom fuselage cover/firewall sealing

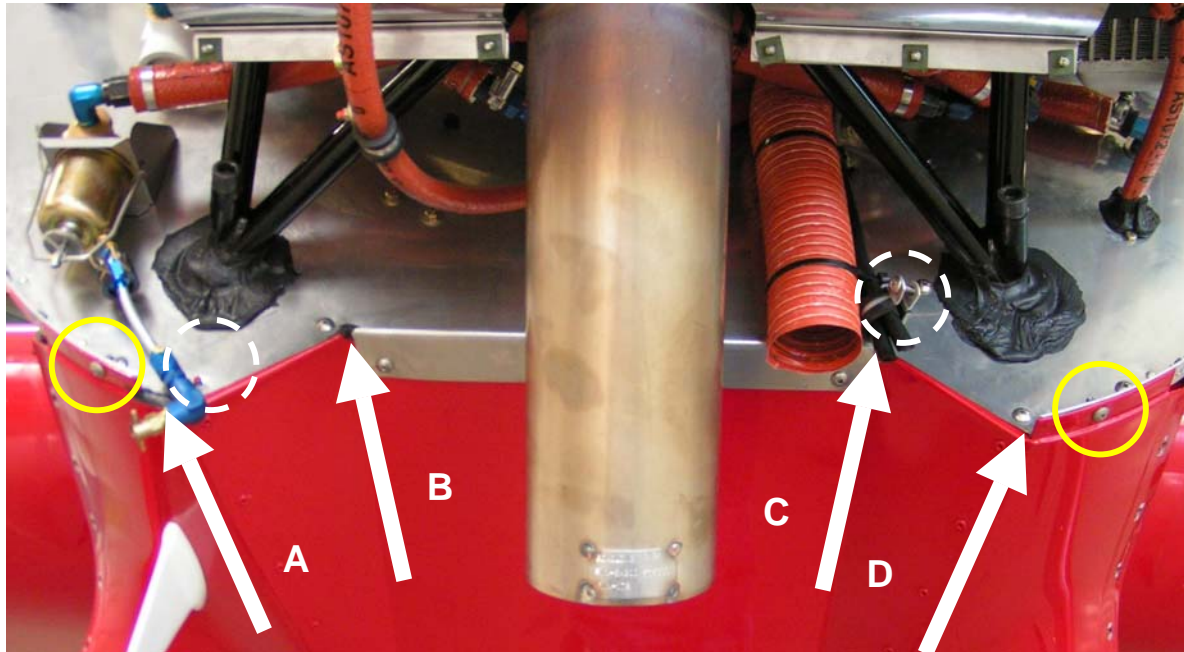
Picture 1: Forward view on bottom side firewall.

Part I To prevent fuel from entering the cockpit, gaps between the bottom fuselage cover (belly fairing) and the firewall need to be sealed with firewall sealant.

To prevent fuel from entering the cockpit, gaps between the bottom fuselage cover and the firewall (locations A through D in Picture 1) need to be sealed. Make sure to repeat the procedure described in Part I of this Service Bulletin every time the bottom fuselage cover is reinstalled. The procedure described in Part I of this Service Bulletin will be included in Chapter 51-00 of the Service Manual, at which time Part II of this Service Bulletin will be withdrawn.

1. Remove engine cowling and the landing gear cuffs according to Chapter 51-00-01 of the Service Manual.
2. Fixate the bottom fuselage cover in its original position by fastening the bottom screws (one on either side), see two outer circles in Picture 1. Loosen the clamp screws on the gascolator drain and on the fuel pump vent lines for easy access, see inner dotted circles in Picture 1.

3. Prepare the PR-812 firewall sealant by mixing brown part A with black part B with weight ratio 2.5:100.
4. Clean the area (from inside and outside) with solvents at the four positions pointed out by the arrows in Picture 1. Immediately thereafter, dry these areas with a new dry cloth.

5. At the gascolator drain (position A), with fastened bottom screw (see 2), seal the remaining gap between the firewall and the bottom fuselage cover from the inside and the outside with the PR-812 firewall sealant. At positions B, C and D seal the small openings from the inside and the outside with the PR-812 firewall sealant. Make sure the minimum layer thickness is approximately $\frac{1}{8}$ inch (≈ 3 mm).

6. Let the sealant cure for at least 24 hours at room temperature.
7. Fasten the clamp screws on the gascolator drain and on the fuel pump vent lines and reinstall the landing gear cuffs and the engine cowling according to Chapter 51-00-01 of the Service Manual.
